CHAPTER 2 – PRODUCT INSTALLATION AND MONITORING

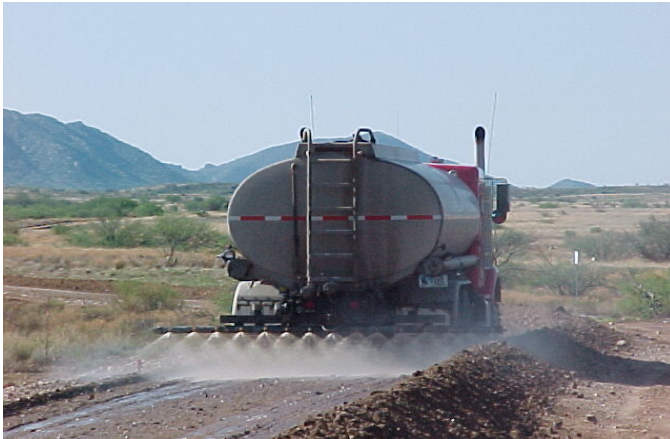
Figure 5. Photo. Typical product application.

All products shown in Table 3 were applied according to each supplier’s recommendation. Each company provided an on-site representative to ensure their product was applied properly in two to three applications as they requested. Each product was applied to the roadway materials in windrows; blade mixed, and then compacted with a 9.4 Mg (12-ton) 9-wheel pneumatic roller to a total stabilized depth of 150 mm (6 in.) Figures 5, 6, and 7 show the typical process used to apply the products on the Buenos Aires NWR Tour Roads project.

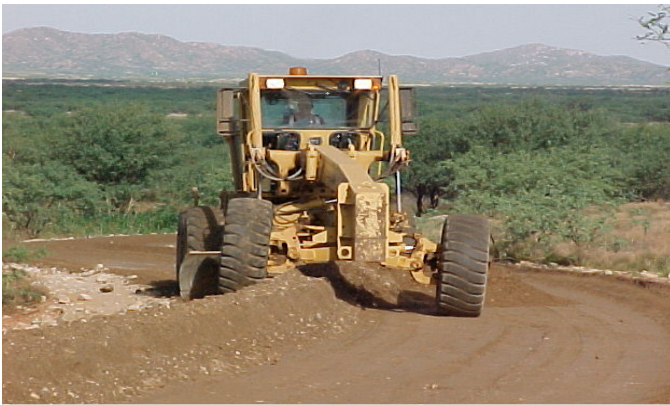
Figure 6. Photo. Typical borrow material and product blending.

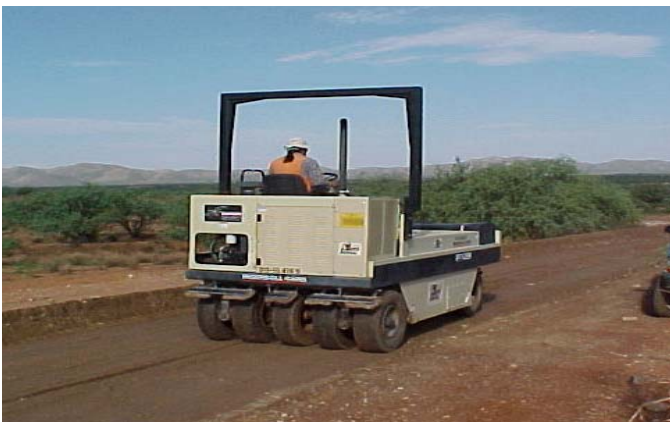
Figure 7. Photo. Typical rolling and compaction.

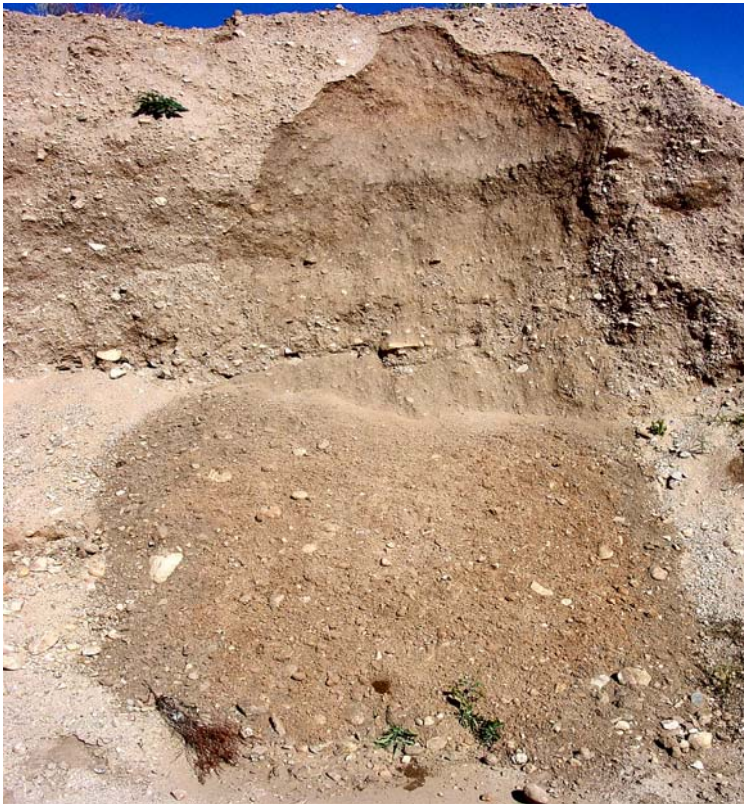
**Figure 8. Photo. Stockpile of granular material used for topping.**

Material from a wash of a local dry streambed was used as the borrow source for the select topping. This borrow material was generally of good quality and met the Special Contract Requirement Section 704.08<sup>(11)</sup>. The specific borrow characteristics prior to and after treatment are discussed in Chapter 4.
